Mobile Intel[®] Pentium[®] II Processor Specification Update

Release Date: December 2002

Order Number: 243887-047

The Mobile Pentium[®] II processor may contain design defects or errors known as errata which may cause the product to deviate from published specifications. Current characterized errata are documented in this Specification Update.

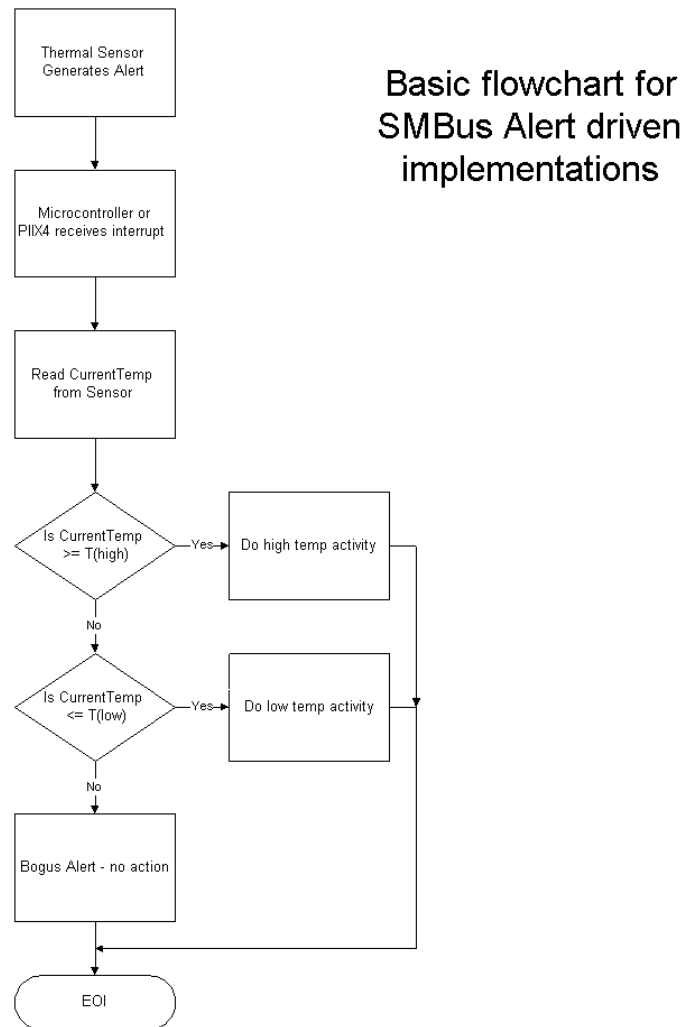
Figure 2. Workaround Flowchart: SMBALERT#-Driven System

Under the conditions described below, the thermal sensor incorrectly generates the SMBALERT# interrupt. All of the following conditions must be met to trigger a false interrupt:

1. Before servicing an interrupt from the thermal sensor, read and compare the processor thermal reading with the threshold limits (T_{HIGH} or T_{LOW}). Figures 2 and 3 provide basic flowcharts for the implementation of this workaround in an interrupt driven system.
2. If the firmware implemented polls the Status Register only, then before taking any action, re-read the temperature register and do a comparison with the alarm threshold limits (T_{HIGH} or T_{LOW}) to determine if the value is actually still within the temperature window.
